**BRIDGE NO. A-02-023 (MARTIN STREET OVER FORT POND BROOK)****Bridge Description and Orientation:**

The Martin Street Bridge over Fort Pond Brook is a twin corrugated steel pipe arch culvert that was built in 1965 (see Sketches and Photos #1, #2 & #3). Martin Street, at the bridge, is oriented North and South over the Fort Pond Brook which flows West to East. The pipe arches are labeled South and North.

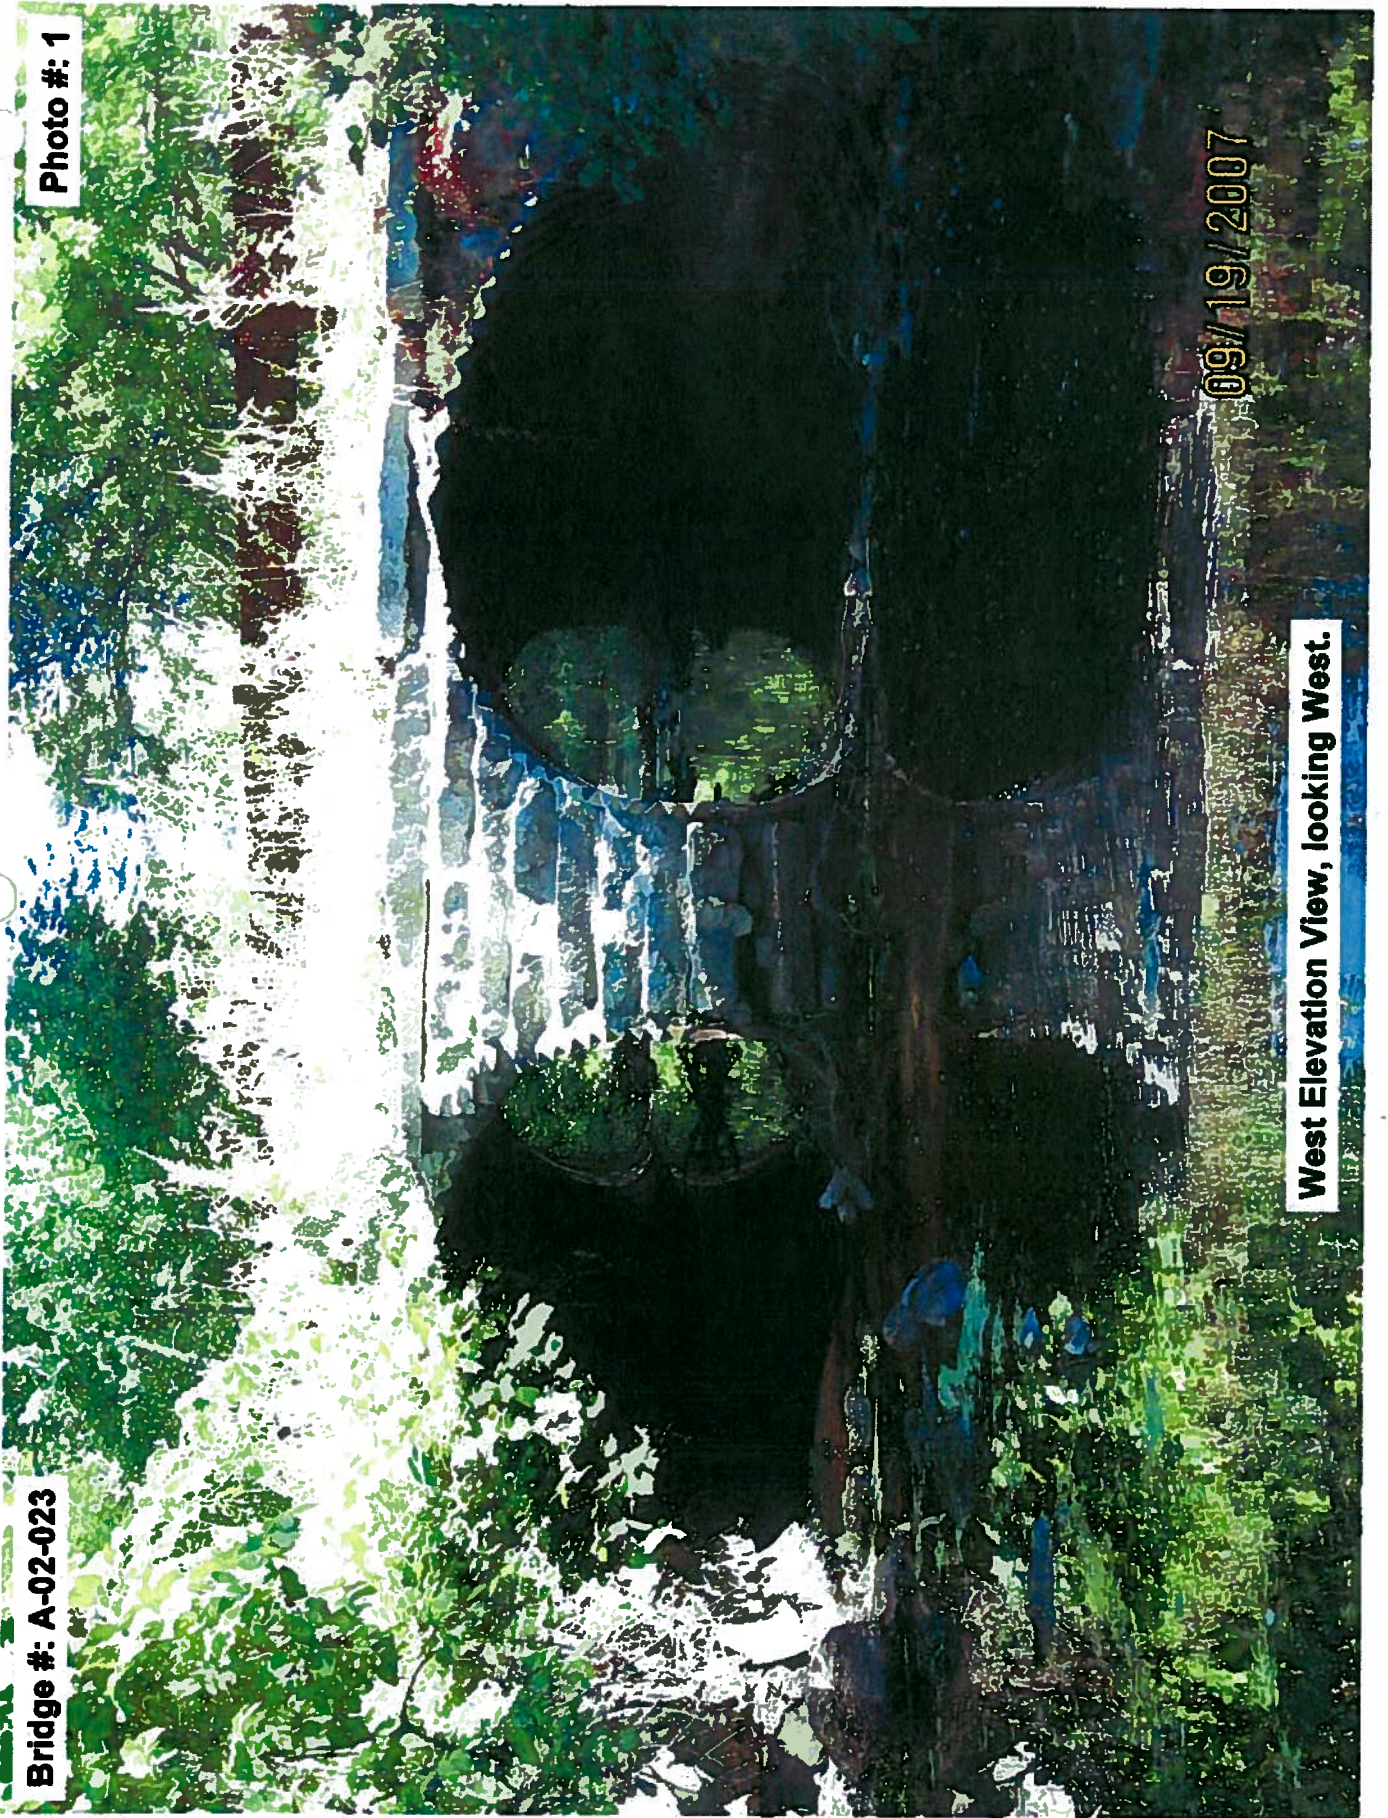
Photo #: 1

West Headwall	<ul style="list-style-type: none"> Light to heavy vegetation growth Random narrow to medium cracks in mortar, minor settlement of the stone throughout and minor erosion at the South side of the South pipe arch Void in 2nd row from channel bottom between pipe arches that measures full width x 6"H x up to 19" of penetration Void between South face of North pipe arch and West headwall that measures 16"H x 2"W x up to 26" of penetration 	11 1 1
East Headwall	<ul style="list-style-type: none"> Wide crack in mortar over South pipe arch Void at the North face of the South pipe arch and the headwall that measures 11"H x 8"W x up to 1" of penetration 	2

• Void at bottom of headwall between pipe arches that measures 8.5"L x 3"W x up to 12" of penetration	2
	• Void at South face of North pipe and headwall that measures 9"H x 6"W x up to 4'-9" of penetration	2

West Elevation View, looking West.

#8	Stone masonry headwalls	Narrow to medium cracks in mortar	Repoint stone masonry headwalls as needed	Low
#9	Pipe arch / headwall ends	Voids around pipe arches and undermining of pipe arches	Fill voids with concrete to seal gaps	High

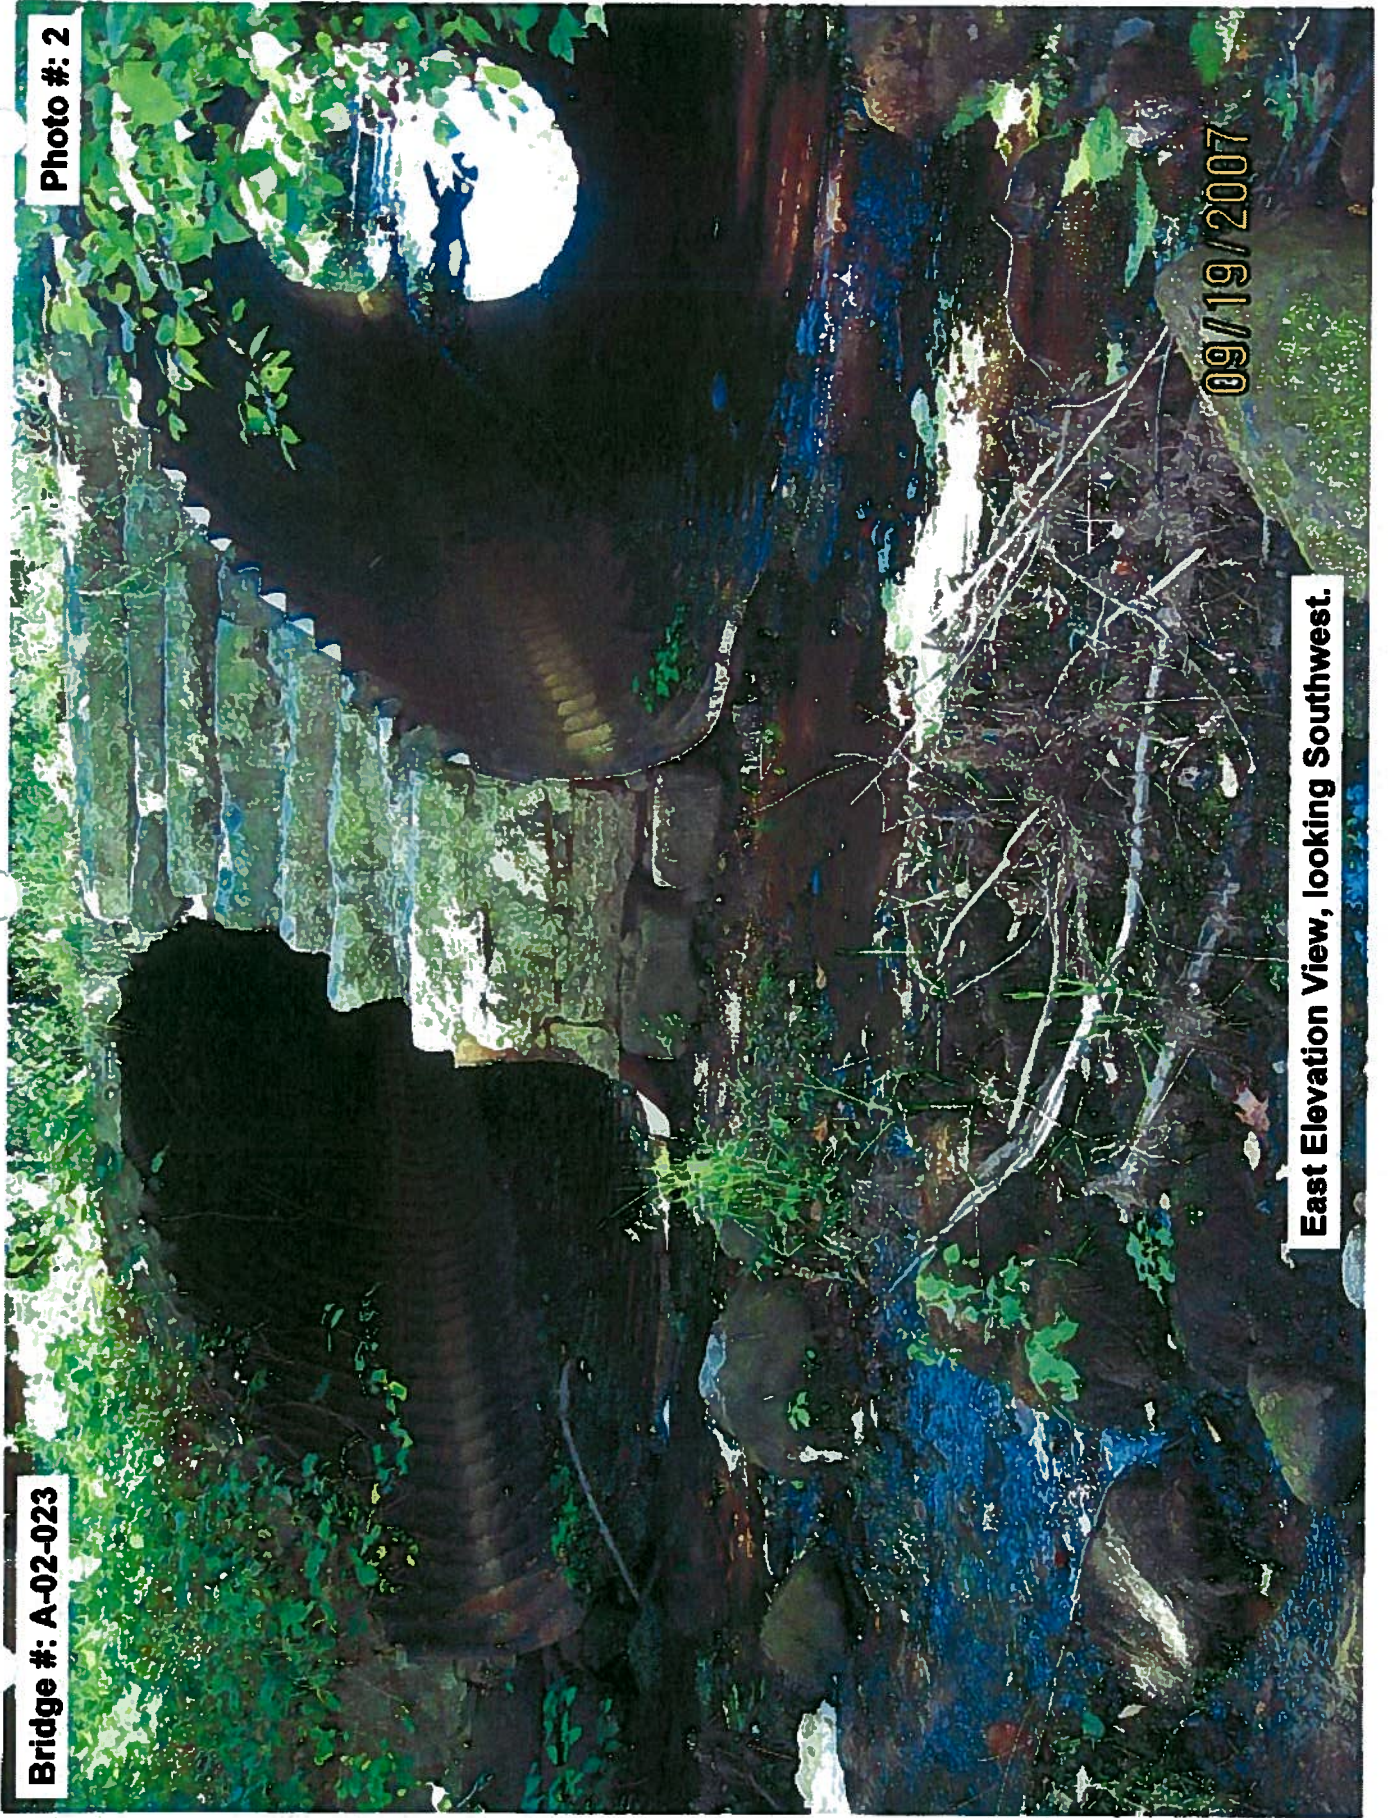
Photo #: 2

East Elevation View, looking Southwest.

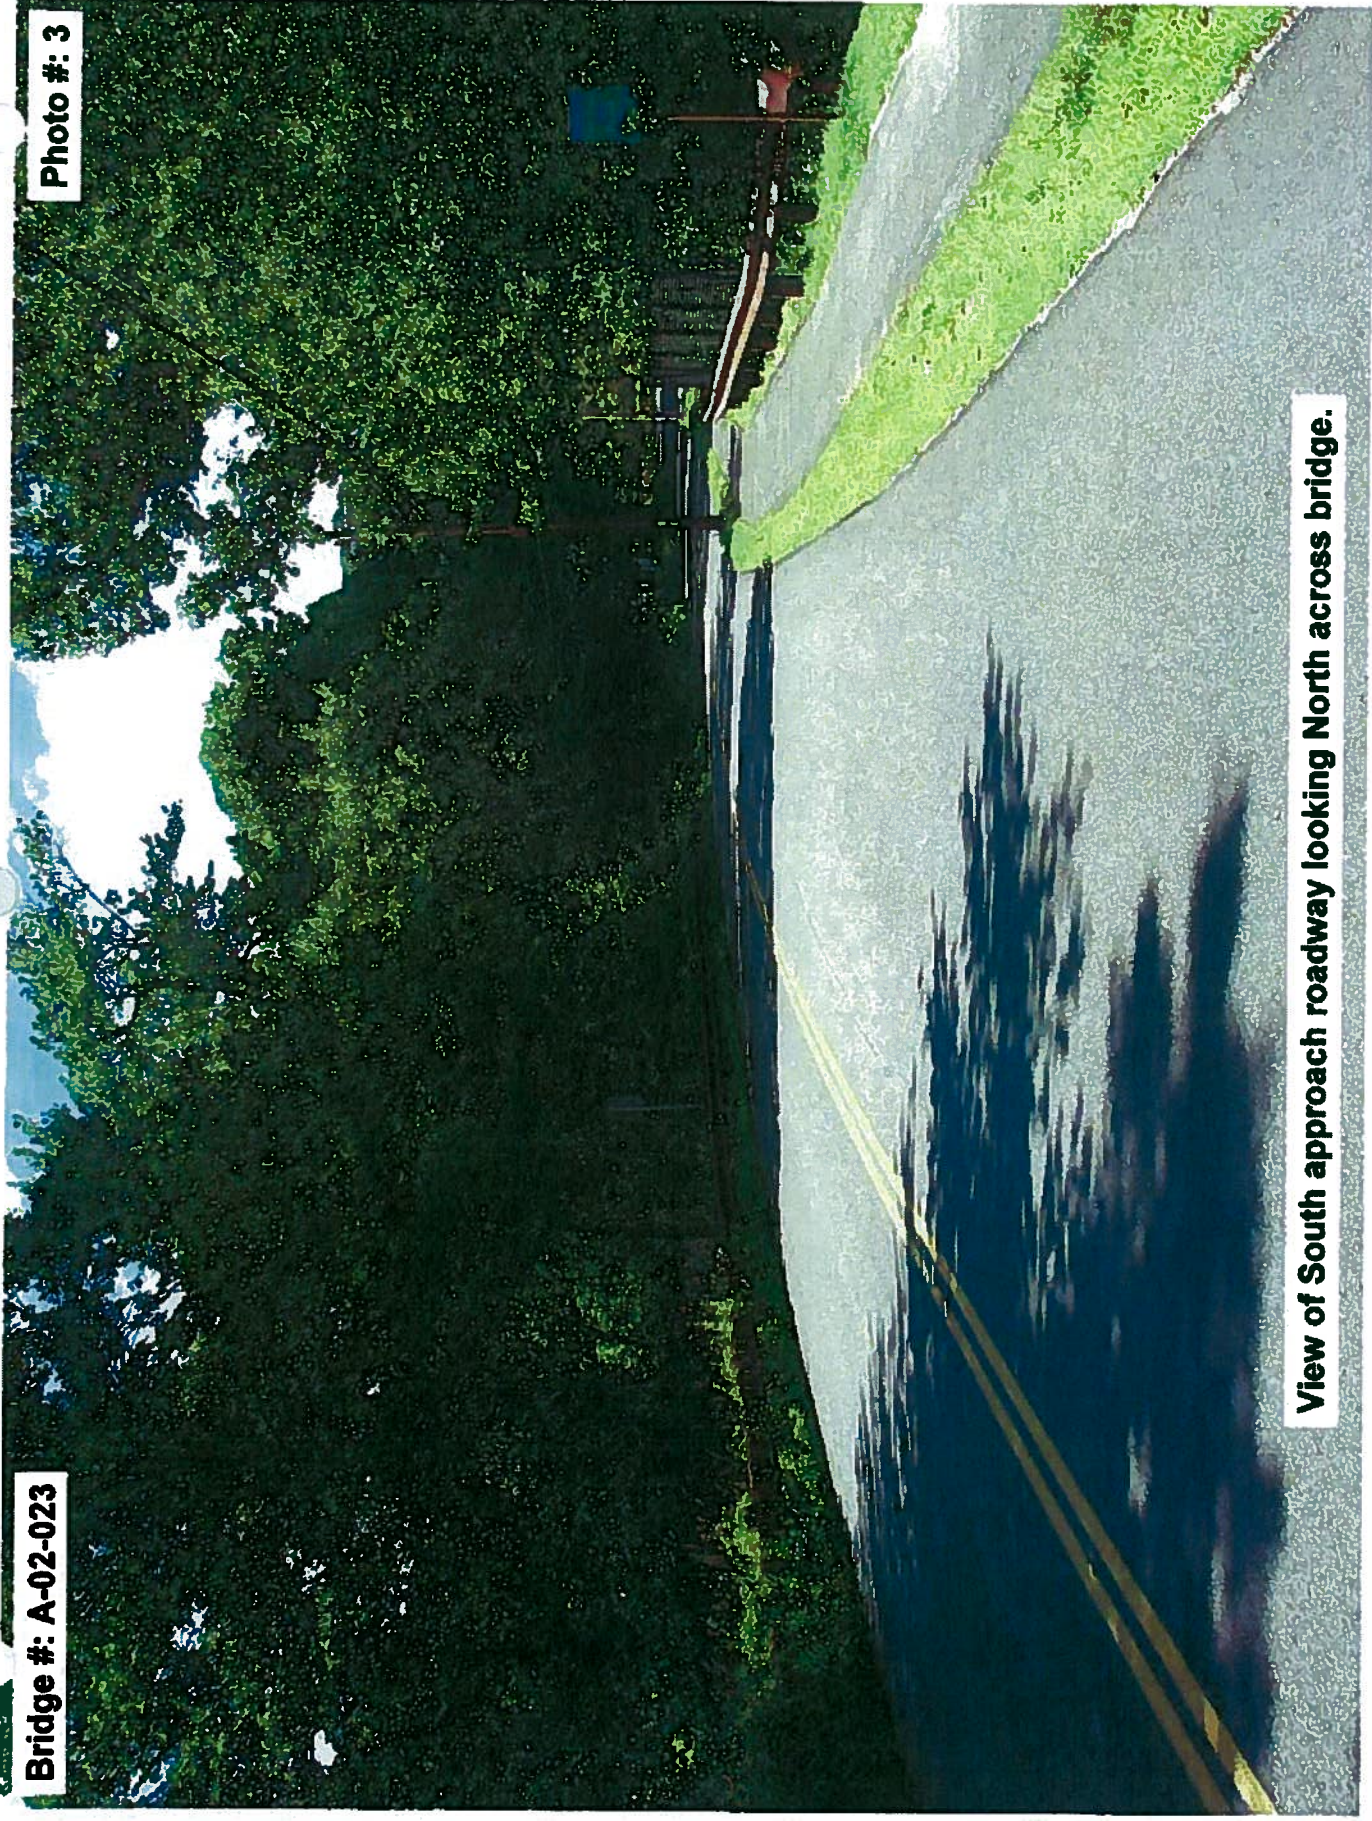
Photo #: 3

Element	Deficiency	Reference Photo(s)
Bridge Rail / Approach Guardrail	<ul style="list-style-type: none">No deficiencies noted	3

Element	Deficiency	Reference Photo(s)
Wearing Surface	<ul style="list-style-type: none">Light to moderate vegetation growth at all 4 approaches to the bridge	3

View of South approach roadway looking North across bridge.

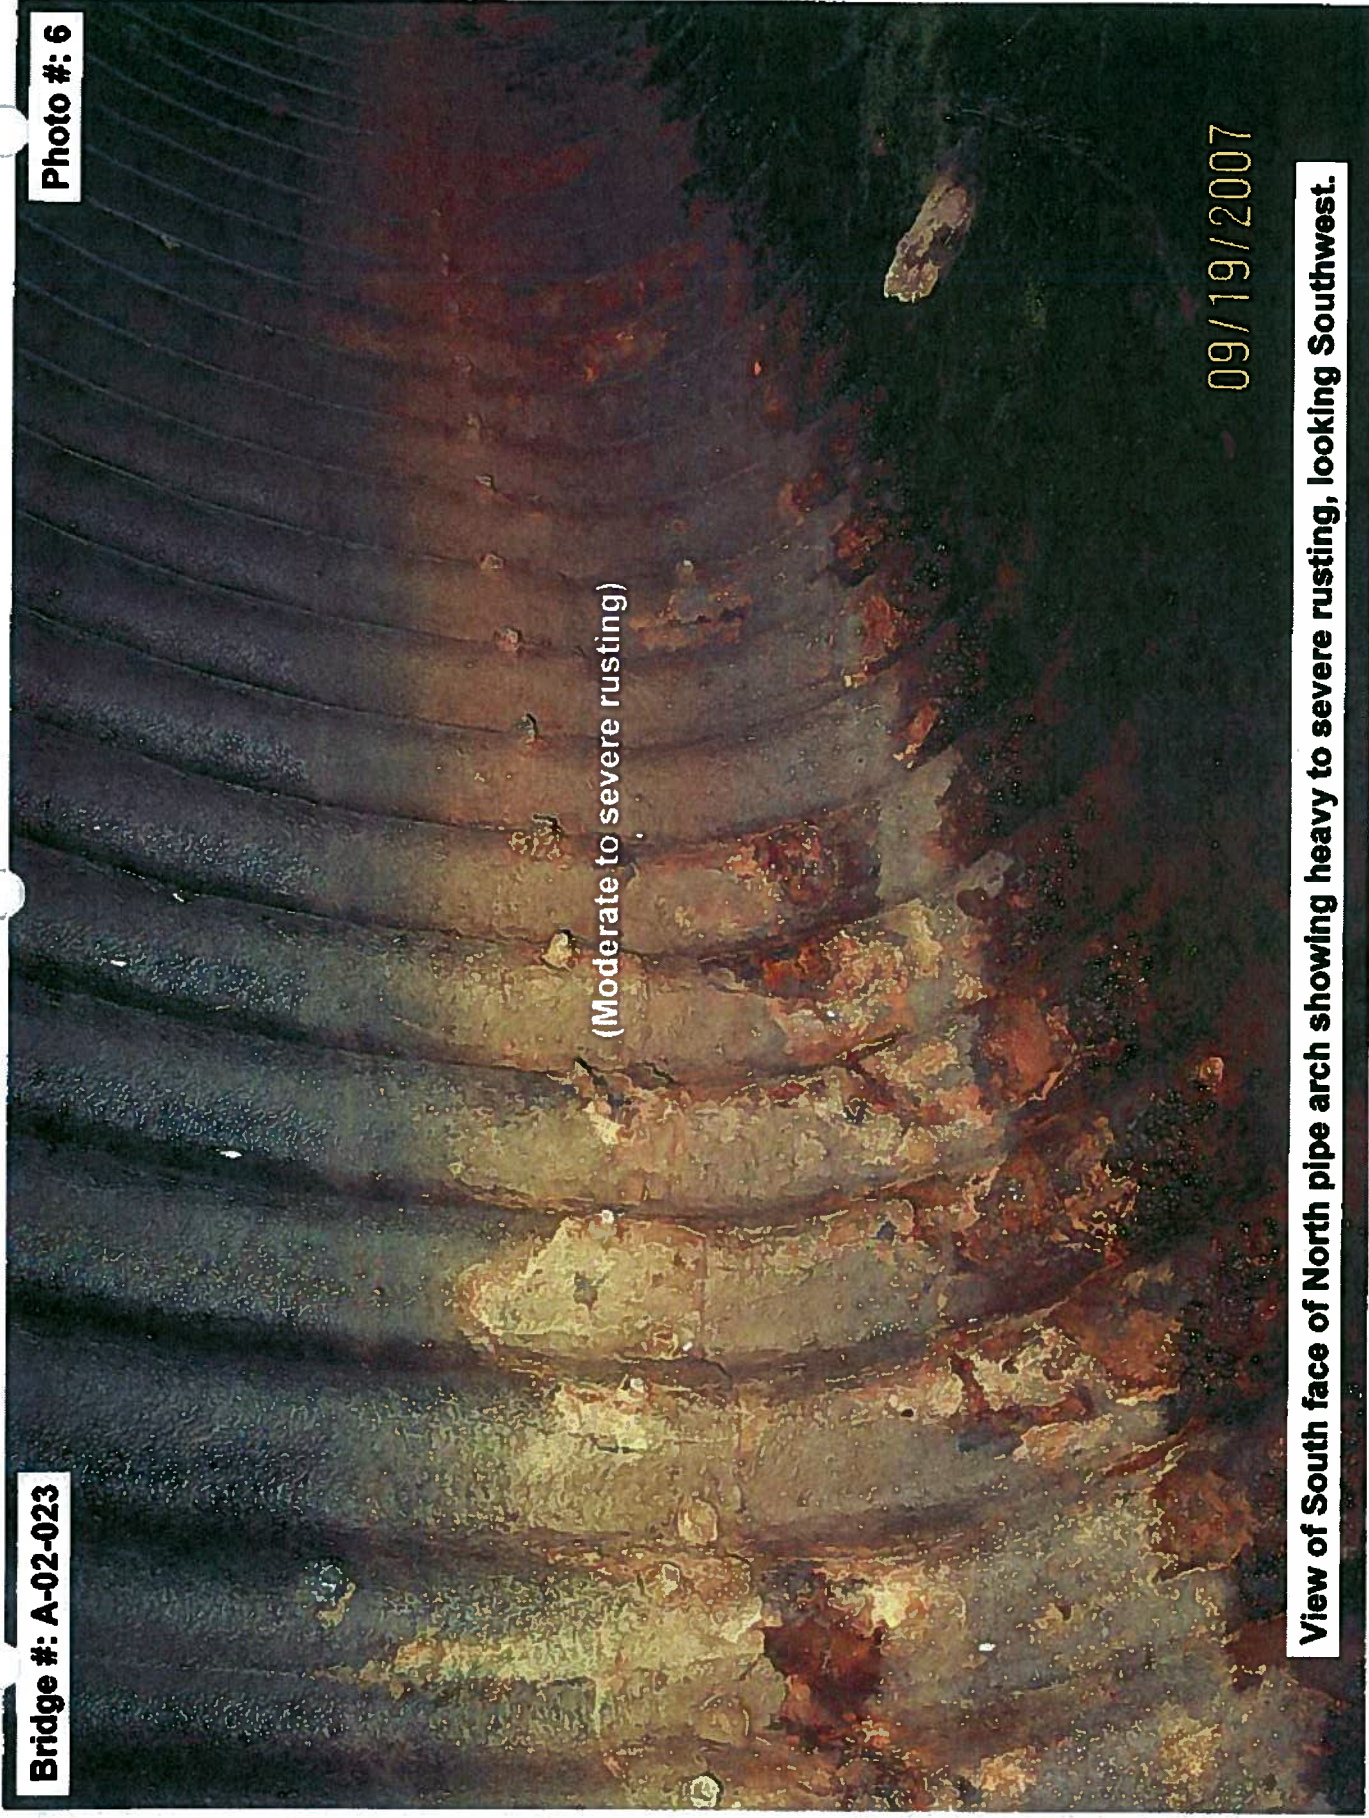
Photo #: 6

Element	Deficiency	Reference Photo(s)
Corrugated Steel Pipe Arch Culvert	<ul style="list-style-type: none">Random missing connection bolts and minor deterioration of the protective coating with the majority of the protective coating failing along the waterlineMinor accumulation of debris along the bottom of both pipe archesModerate aggradation at the West end of both pipe archesEast end of North and South pipe arches are undermined up to 8"West end of North and South pipe arches are undermined up to 12"	2
	<ul style="list-style-type: none">Moderate to severe rusting with minor steel delamination along the lower haunch of both pipe arches, located approximately 12" above the bottom of barrel, just below the seam of the arch sections	4, 5, 6

(Moderate to severe rusting)

View of South face of North pipe arch showing heavy to severe rusting, looking Southwest.

#4	Haunch of both pipe arches	Moderate to severe rusting	Pave inverts full length within normal water range	High
#5	South pipe arch, South face	Numerous holes in arch at haunch	Repair holes prior to placing new paved invert	High

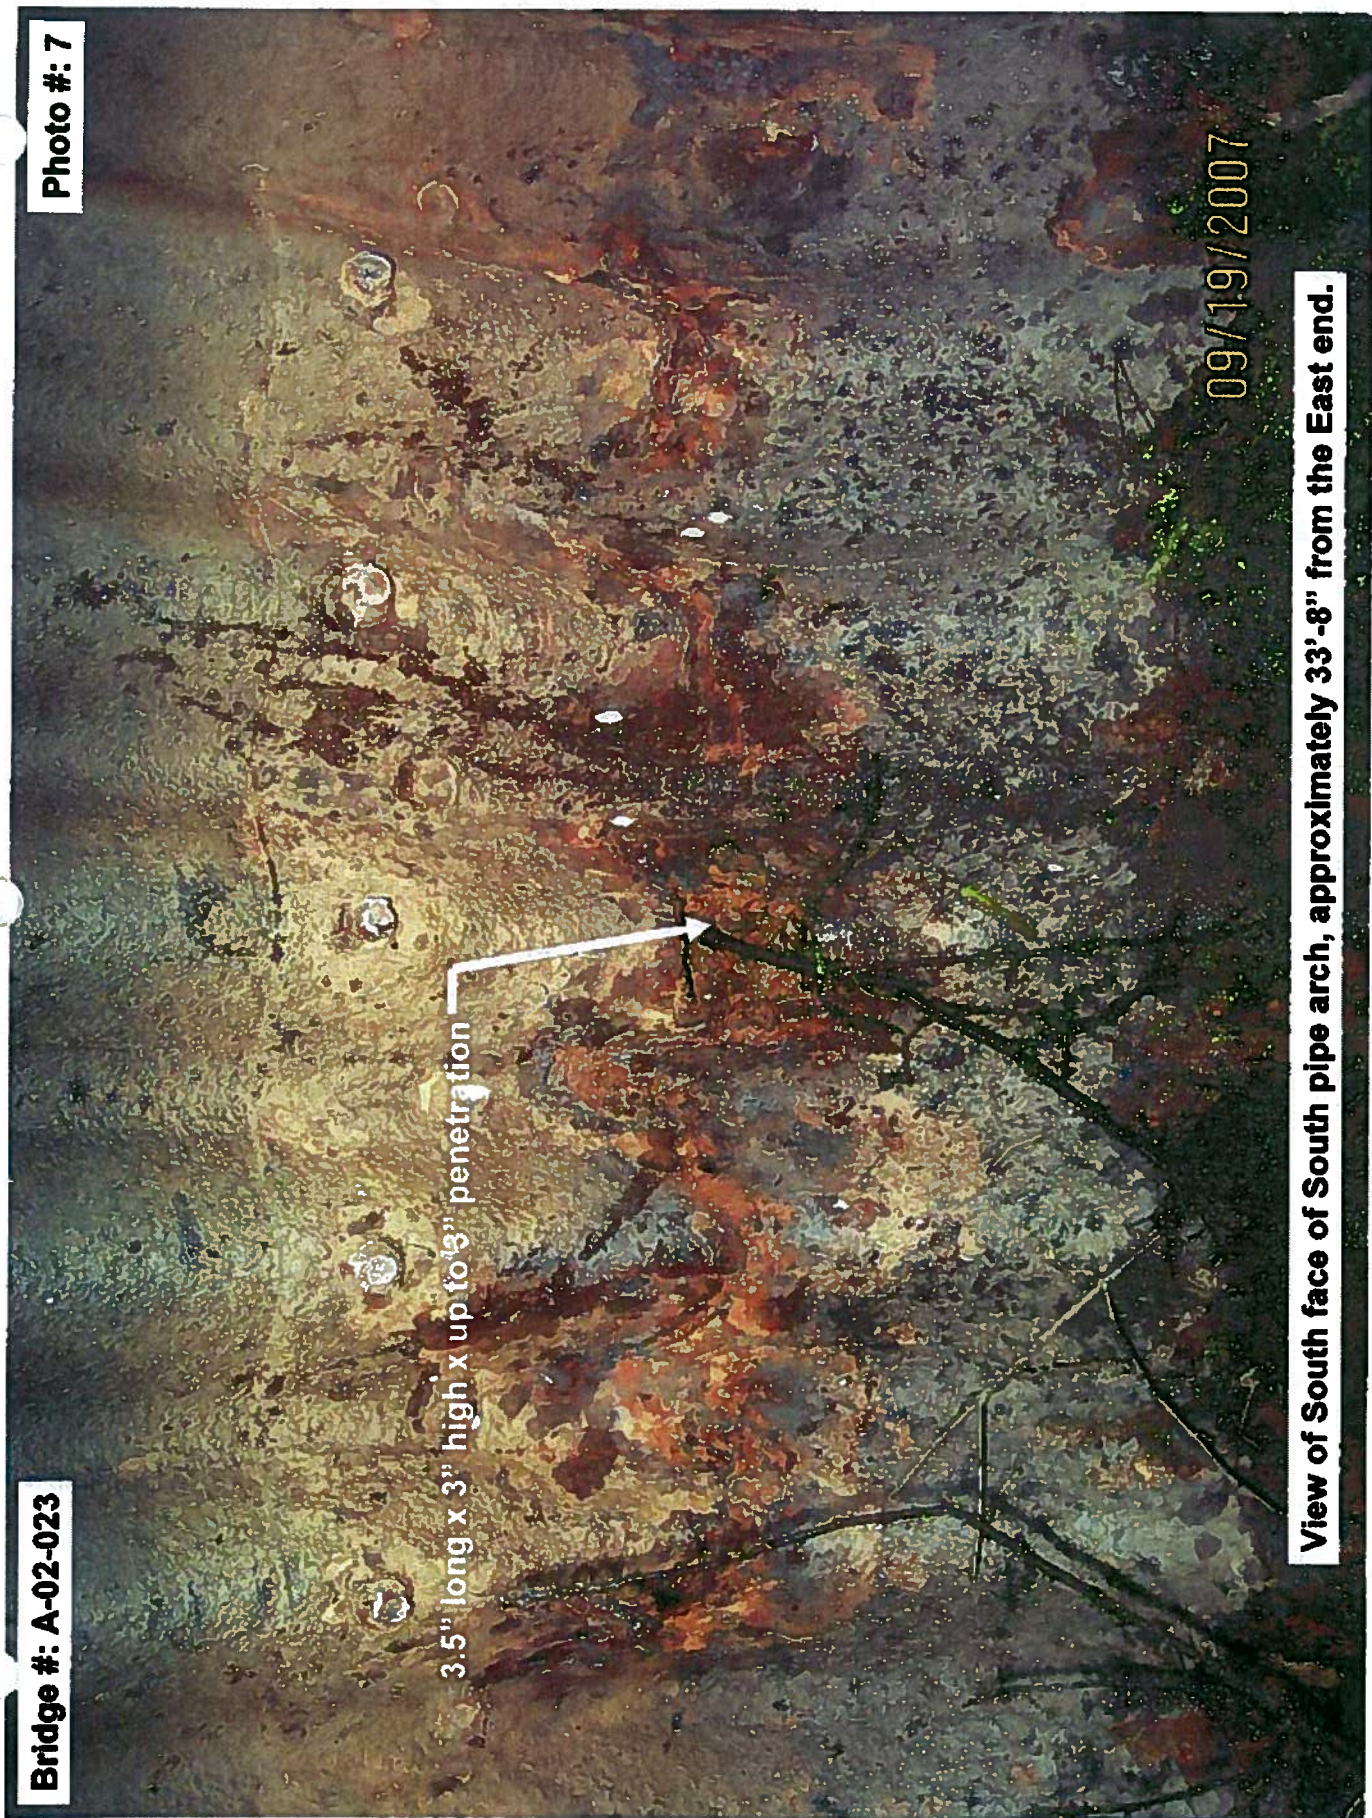
Photo #: 7

<ul style="list-style-type: none"> Hole in South pipe arch (North face), located 8'-7" from East end, that measures 2"L x 5"H x up to 4" of penetration Hole in South pipe arch (South face), located 12'-0" from East end, that measures 1" in diameter x up to 1.5" of penetration Hole in South pipe arch (South face), located 13'-6" from East end, that measures 2.5"L x 1.5"H x up to 2.5" of penetration Hole in South pipe arch (South face), located 21'-8" from East end, that measures 2"L x 2.5"H x up to 1" of penetration Hole in South pipe arch (South face), located 33'-8" from East end, that measures 3.5"L x 3"H x up to 3" of penetration 3 holes in South pipe arch (South face), located 36'-8" from East end, that measure 3"L x 3"H x up to 3" of penetration, 4"L x 5"H x up to 3.5" of penetration and 3"L x 5"H x up to 4" of penetration Hole in North pipe arch (North face), located 16'-0" from East end, that measures 1"L x 2"H x up to 1" of penetration Hole in North pipe arch (North face), located 18'-6" from East end, that measures 3"L x 3"H x up to 1" of penetration Hole in North pipe arch (North face), located 27'-0" from East end, that measures 2"L x 2"H x up to 3" of penetration Hole in North pipe arch (North face), located 40'-0" from East end, that measures 4"L x 5"H x up to 2" of penetration Hole in North pipe arch (North face), located 41'-6" from East end, that measures 4"L x 2.5"H x up to 3" of penetration Hole in North pipe arch (North face), located 42'-0" from East end, that measures 2"L x 1"H x up to 2" of penetration 	7 8 9 10 10 10

3.5" long x 3" high x up to 3" penetration

View of South face of South pipe arch, approximately 33'-8" from the East end.

#6	South pipe arch, North face	Hole in arch at haunch	Repair holes prior to placing new paved invert	High
#7	North pipe arch, North face	Numerous holes in arch at haunch	Repair holes prior to placing new paved invert	High

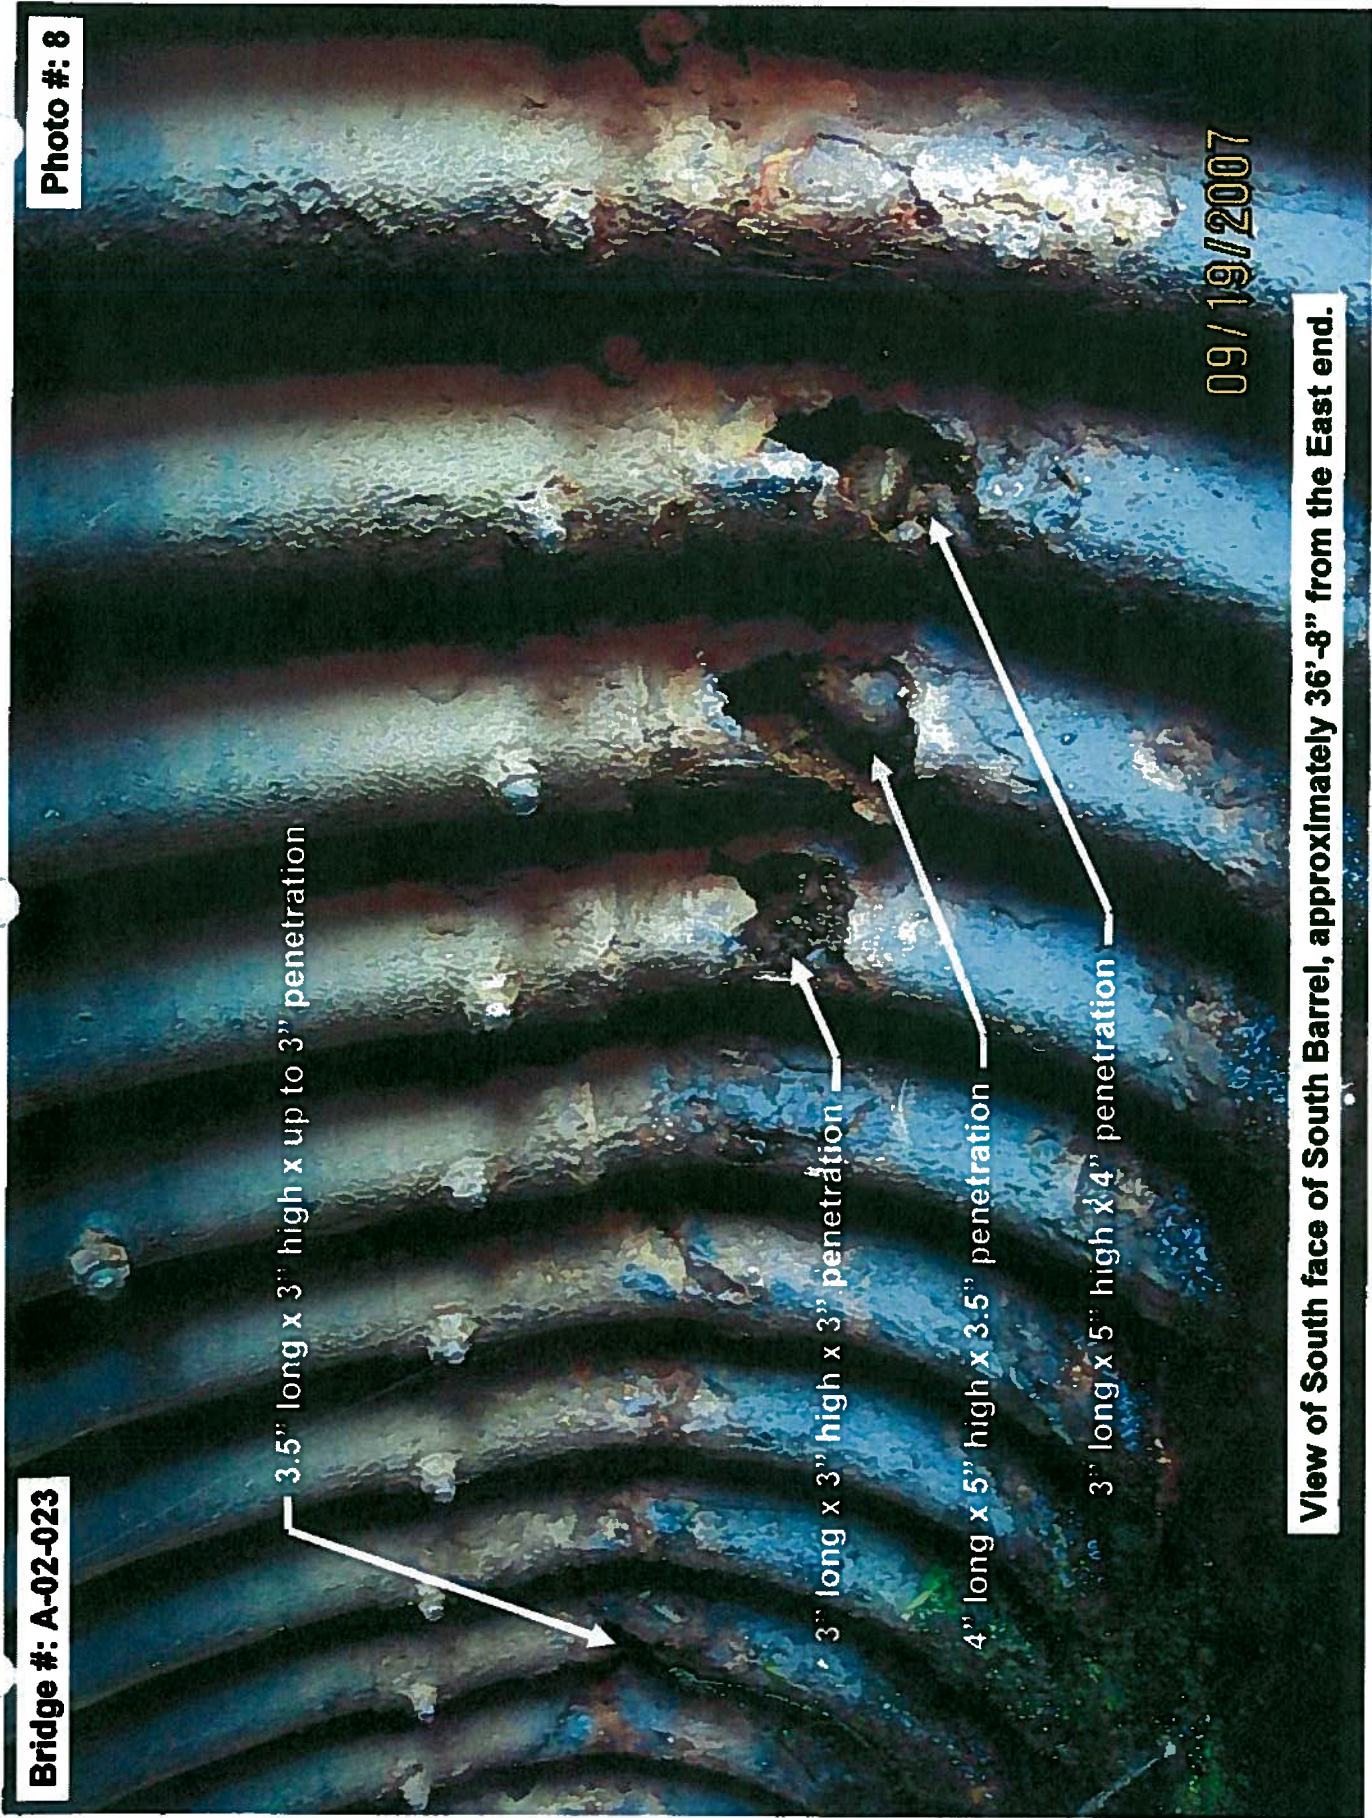
Photo #: 8

3.5" long x 3" high x up to 3" penetration

3" long x 3" high x 3" penetration

4" long x 5" high x 3.5" penetration

3" long x 5" high x 4" penetration

View of South face of South Barrel, approximately 36'-8" from the East end.

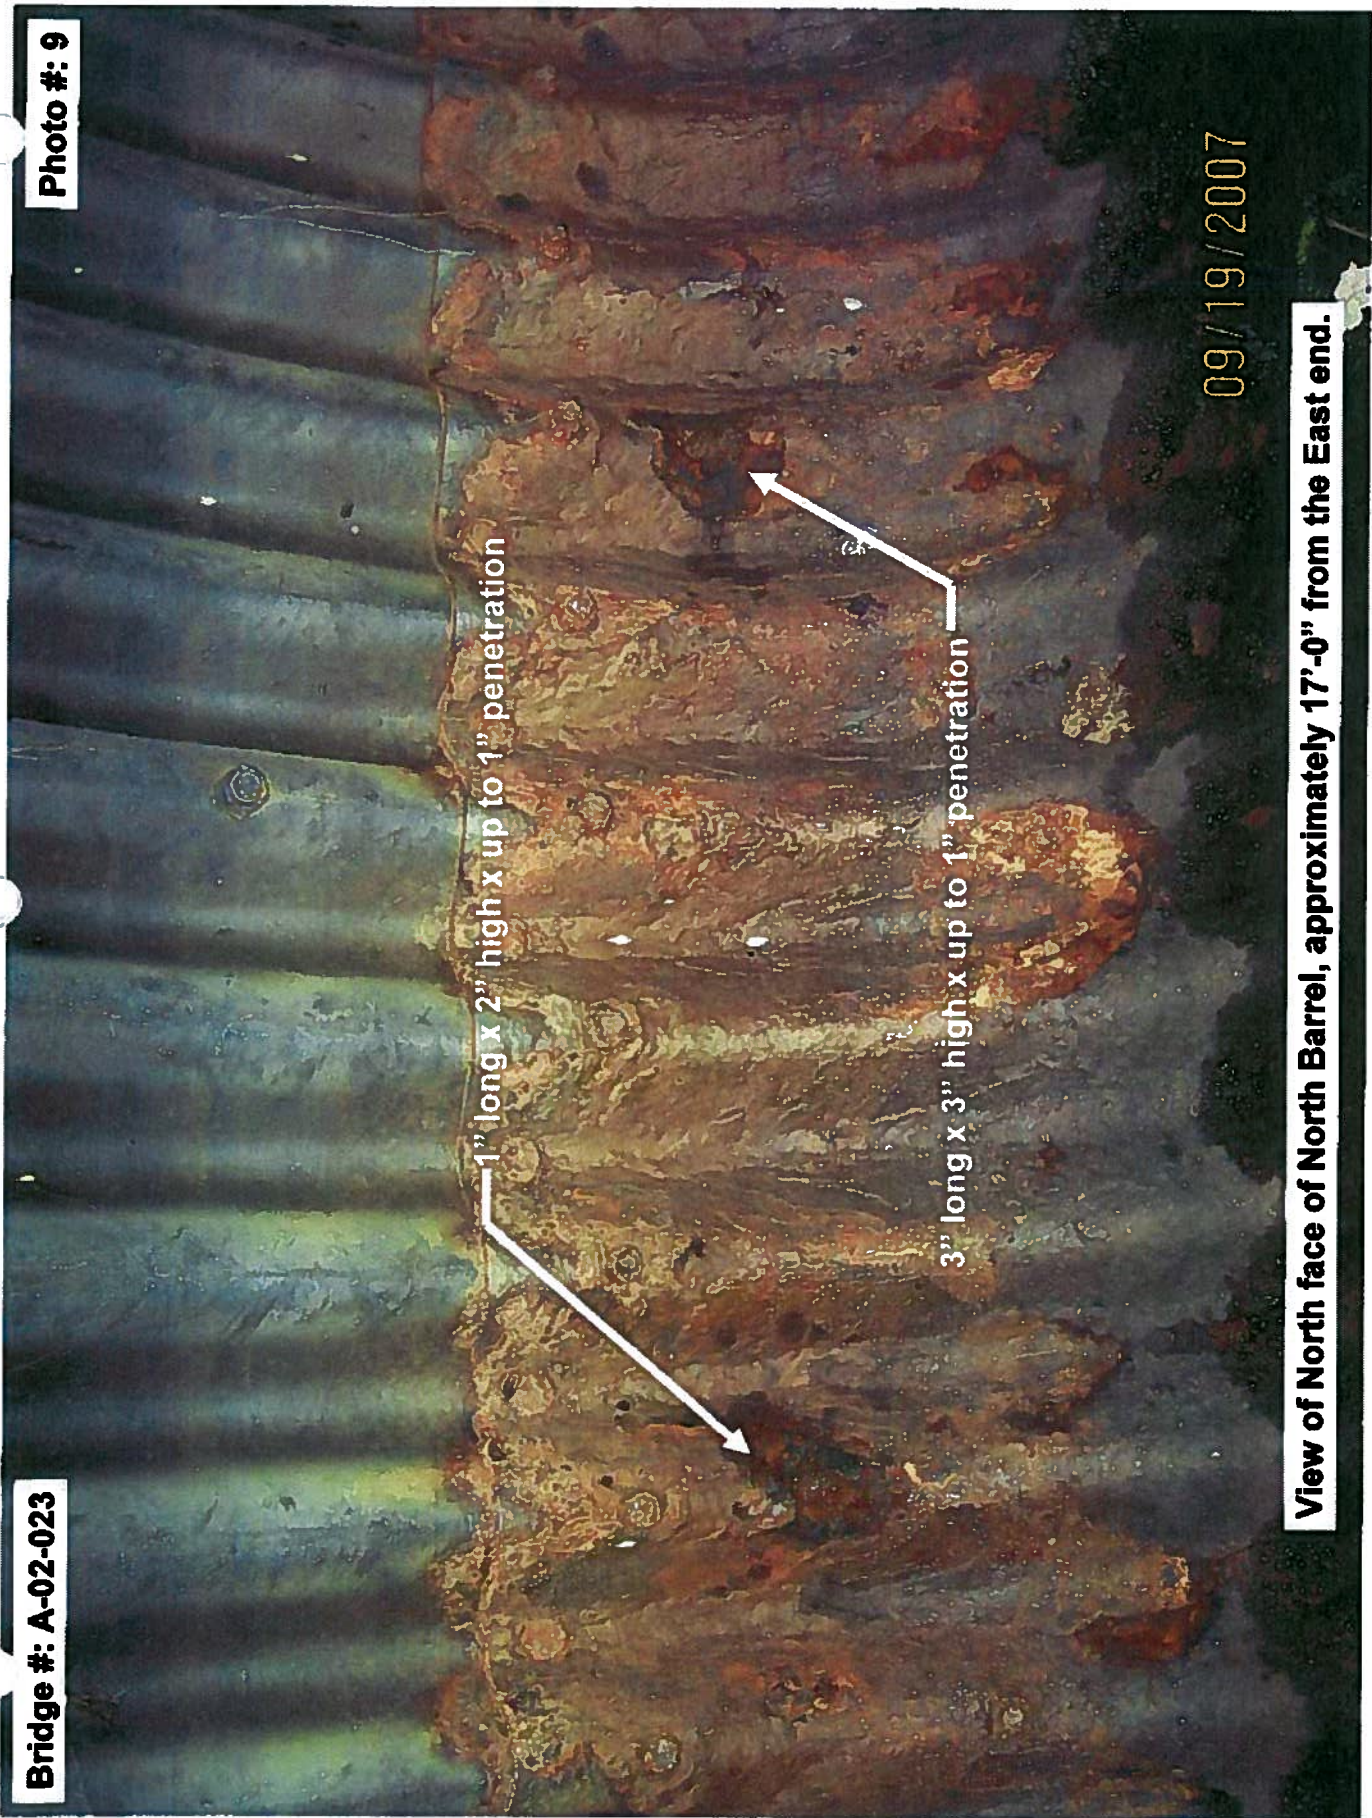
Photo #: 9

1" long x 2" high x up to 1" penetration

3" long x 3" high x up to 1" penetration

View of North face of North Barrel, approximately 17'-0" from the East end.

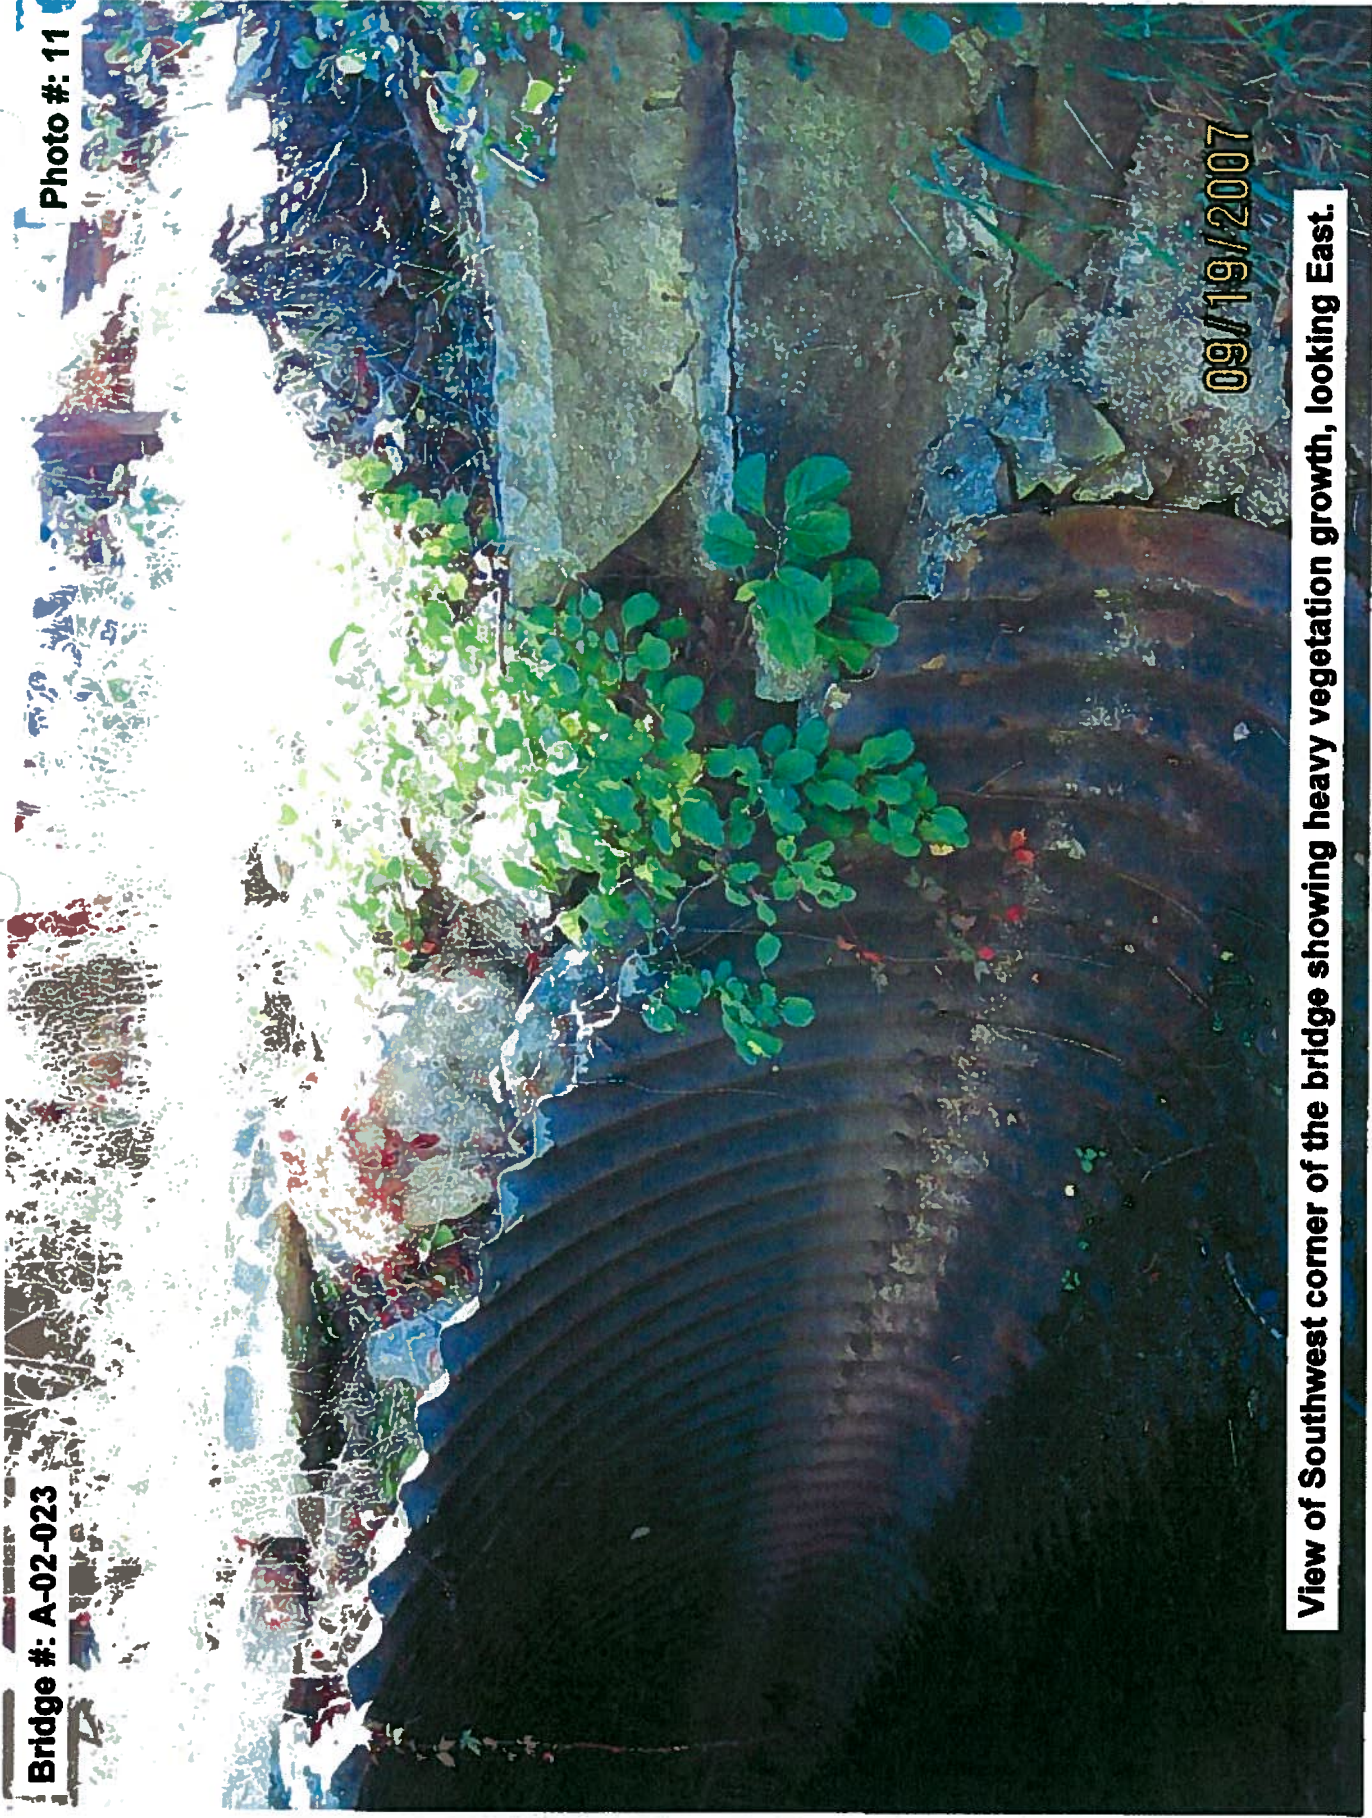
Photo #: 11

View of Southwest corner of the bridge showing heavy vegetation growth, looking East.
